Model: ESI

Feb. 15, 2019

Product Bulletin # TDS-192

Inspection for Guard Access Door Needed

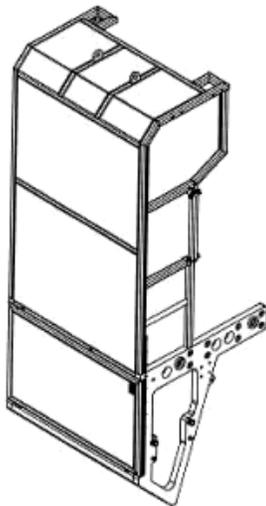
Guard Part #5008022

On ESI Top Drives, a crack could form on the hinge welds of the guard access doors resulting from fatigue or shock loading/vibration. This may lead to a potential dropped object. Early ESI production was equipped with a 1-piece guard # 5008022 that has two access doors. ESI top drives manufactured since August 2015 are equipped with a 2-piece guard # 5038637 that has one access door only.

- Inspect the top drive to determine guard part number.
- Visually inspect the welds of the door hinge sections both to the door and to the guard structure.
- If any visible signs of cracks are found, stop the operation and contact RigLine 24/7™ Support immediately.
- Canrig recommends a regular daily inspection of hoisting equipment to identify cracks and other signs of damage and wear.
