Torq-Matic™ TM80 Undercarriage Cap Screws

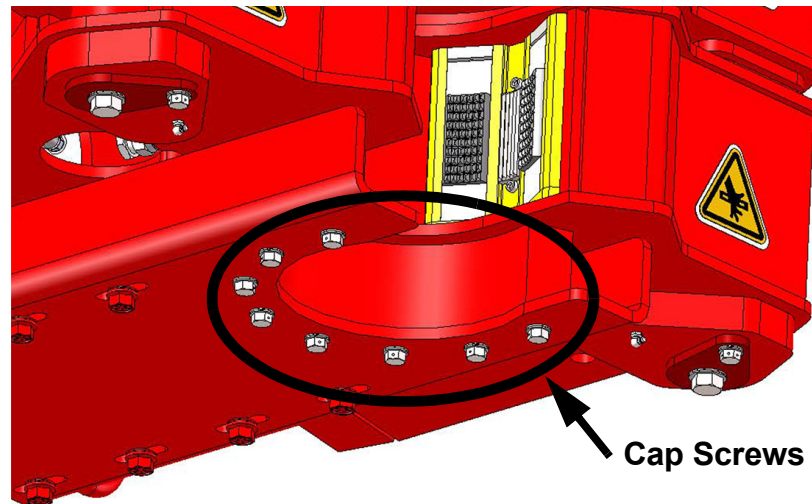
Figure 1: Undercarriage cap screws.

One or more of the eight undercarriage cap screws (see Figure 1) attaching the lower tong frame to the vertical lift frame can shear or work loose as the result of some operational loading conditions. Examples of such operational loading conditions can include the following:

Over time, cyclic loading and/or vibration can begin to loosen or shear the remaining cap screws. If the undercarriage is not inspected regularly and missing or loose cap screws are not replaced or tightened; eventually all of the cap screws will shear or work themselves completely loose and the entire tong and spinner assembly can become separated from the vertical lift assembly.

- Perform preventive maintenance per Canrig TM80 wrench maintenance poster P/N C10175.
 - Visually inspect the undercarriage daily for signs of loose or damaged cap screws.

- Apply a light clockwise force to each undercarriage cap screw with an open-end hand wrench to check for tightness twice a week.

- Torque loose cap screws to 99 ft-lb with a torque wrench or contact RigLine 24/7™ to assist if a torque wrench is not available. If these same fasteners come loose again, contact RigLine 24/7™ for further instructions.
- Ensure the torque and spinner assembly is level by placing a bubble level on top of the upper tongs. Contact RigLine 24/7™ for leveling instructions.
- Install upgrades recommended in next section

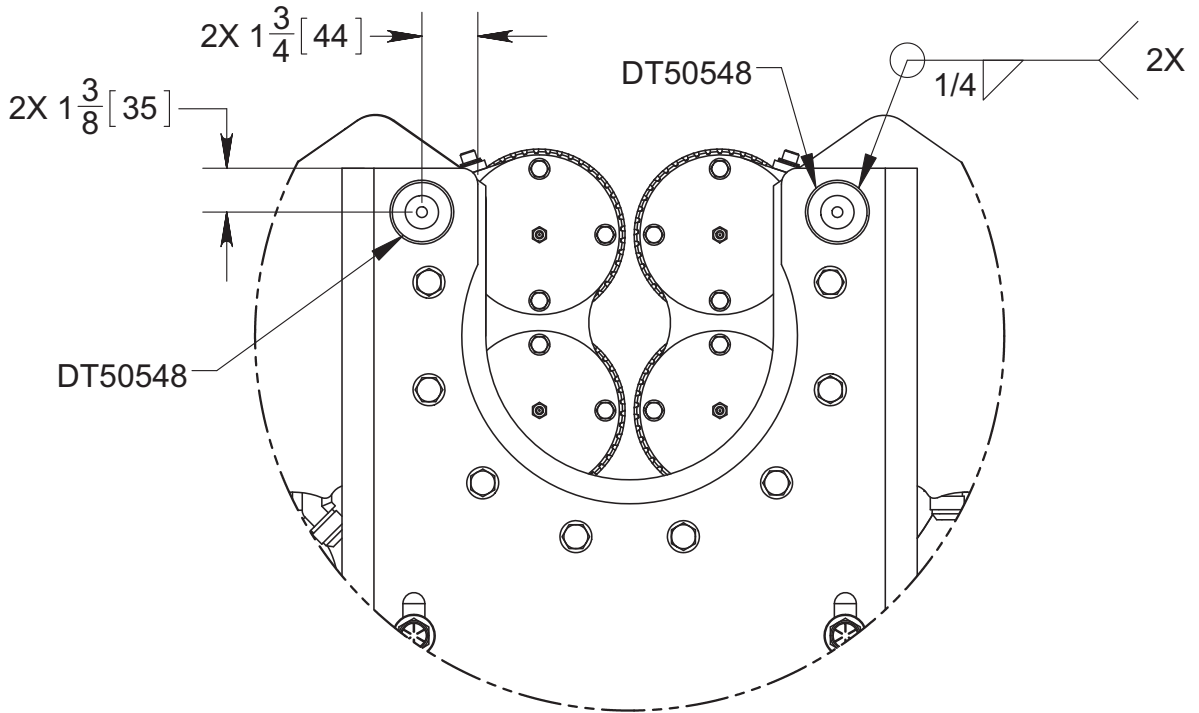
Figure 2: Bumper placement and weld details.

12. Locate and weld the bumpers as indicated in Figure 2 on page 5. Weld per Canrig procedure CRDT-001 or equivalent. Refer to Figure 3 on page 5 for an illustration of installed bumpers. Note: The bumpers are shown in blue for illustration only.

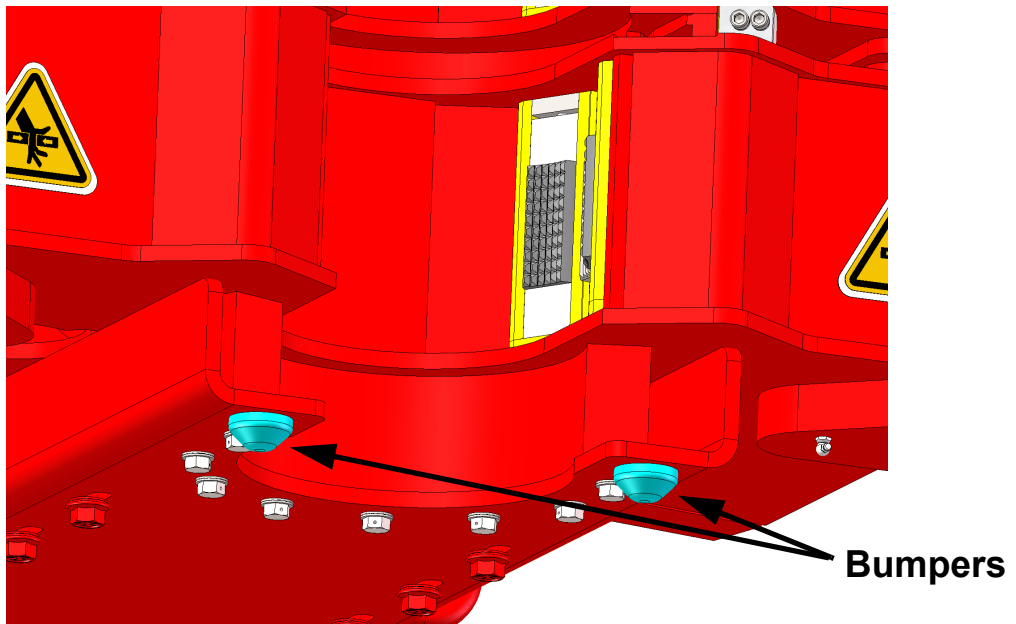
Figure 3: Bumpers installed.

Canrig recommends installing bumpers on the vertical lift weldment. The bumpers will help protect the heads of the cap screws in case the undercarriage contacts the ground.
