SAFETY ALERT

SUBJECT: MUDLINE SUPPORT BRACES

SERIAL NUMBERS: 17, 22, 23

PRODUCT BULLETIN NUMBER: 51-2

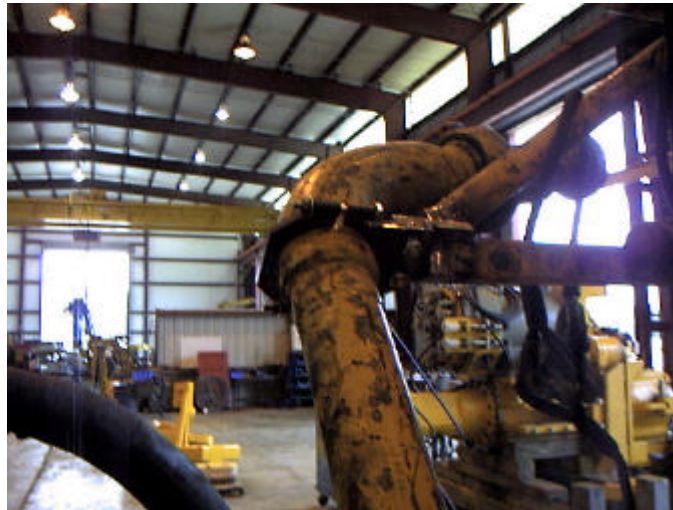
Figure 1-Good Support

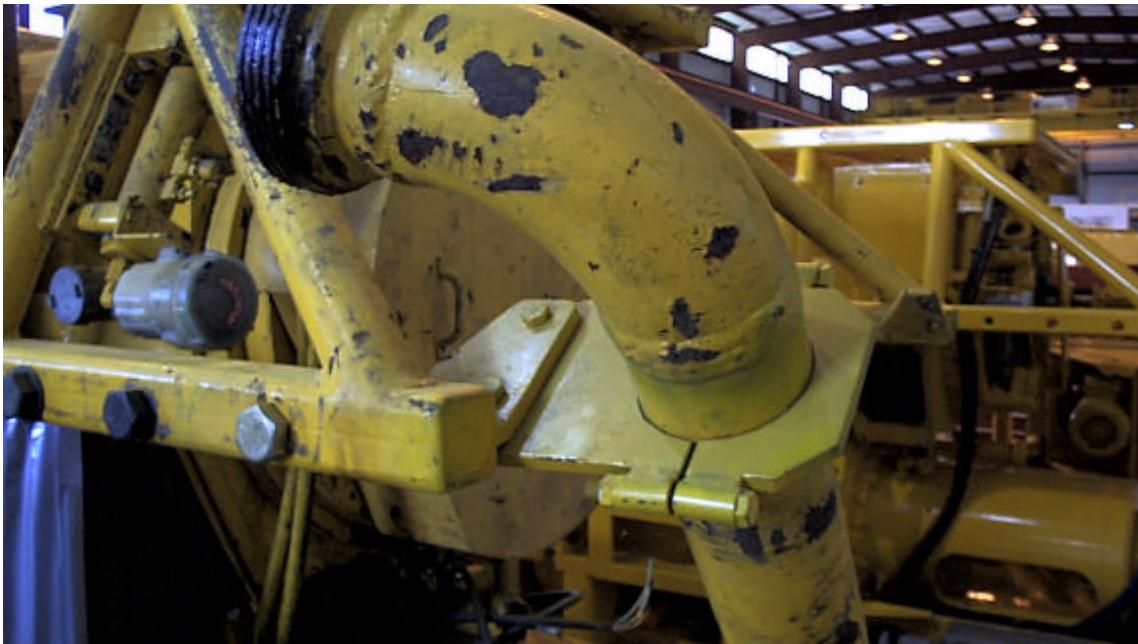
Figure 2-Good Support

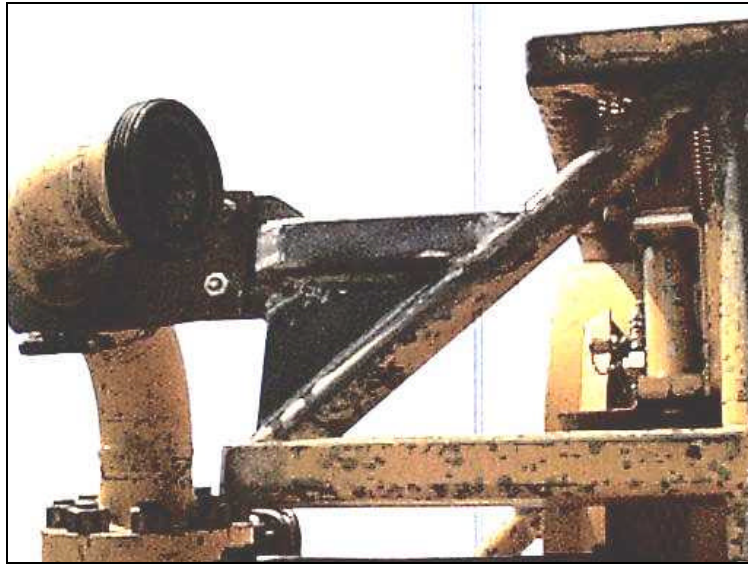
Figure 3-Good Support

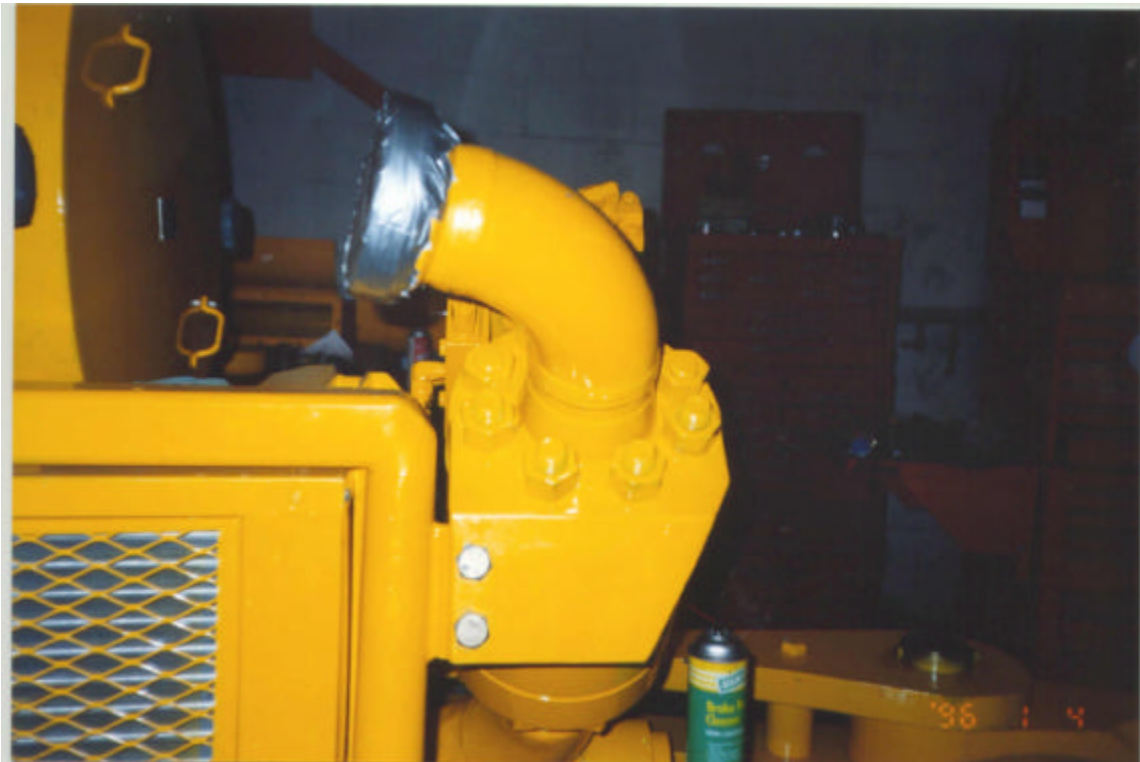
Figure 4-Good Support

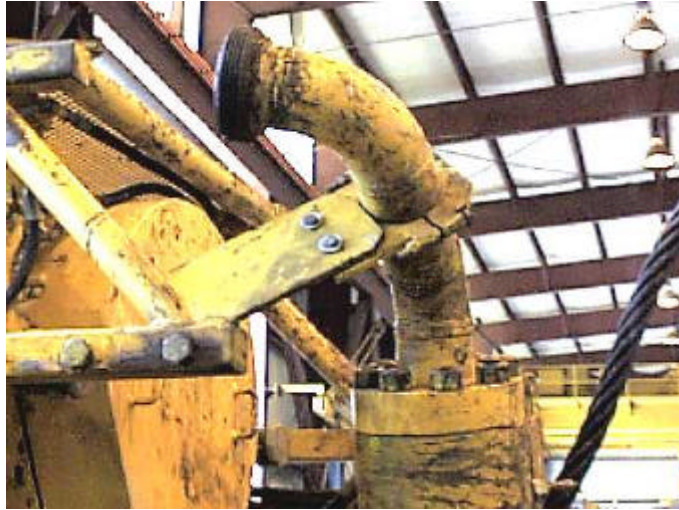
Figure 5-Insufficient Support

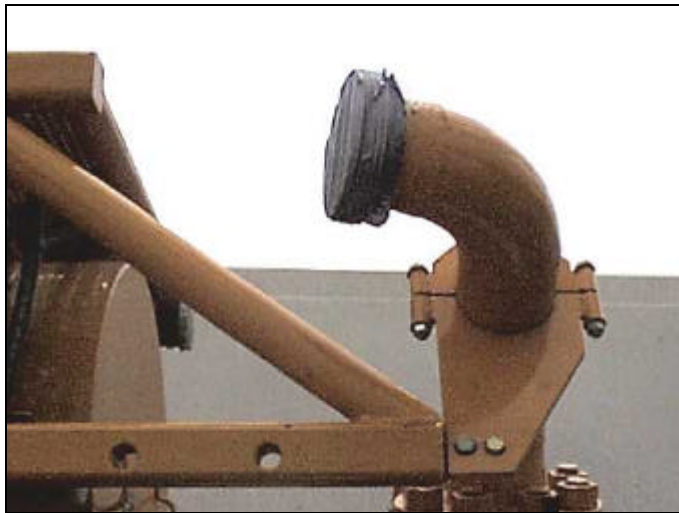
Figure 6-Insufficient Support

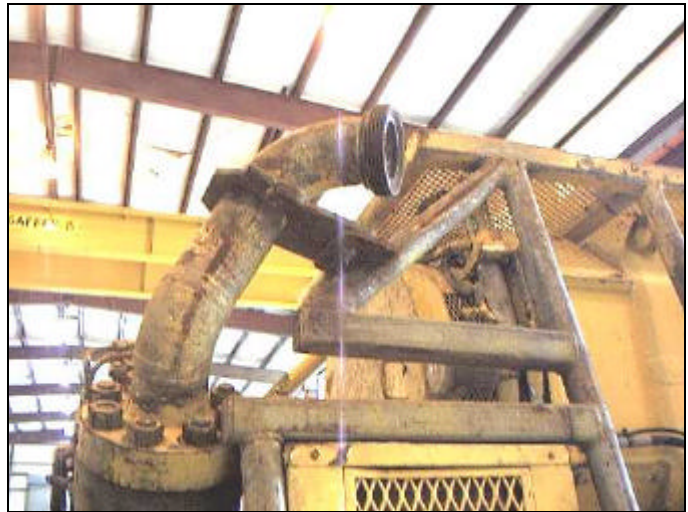
Figure 7-Insufficient Support

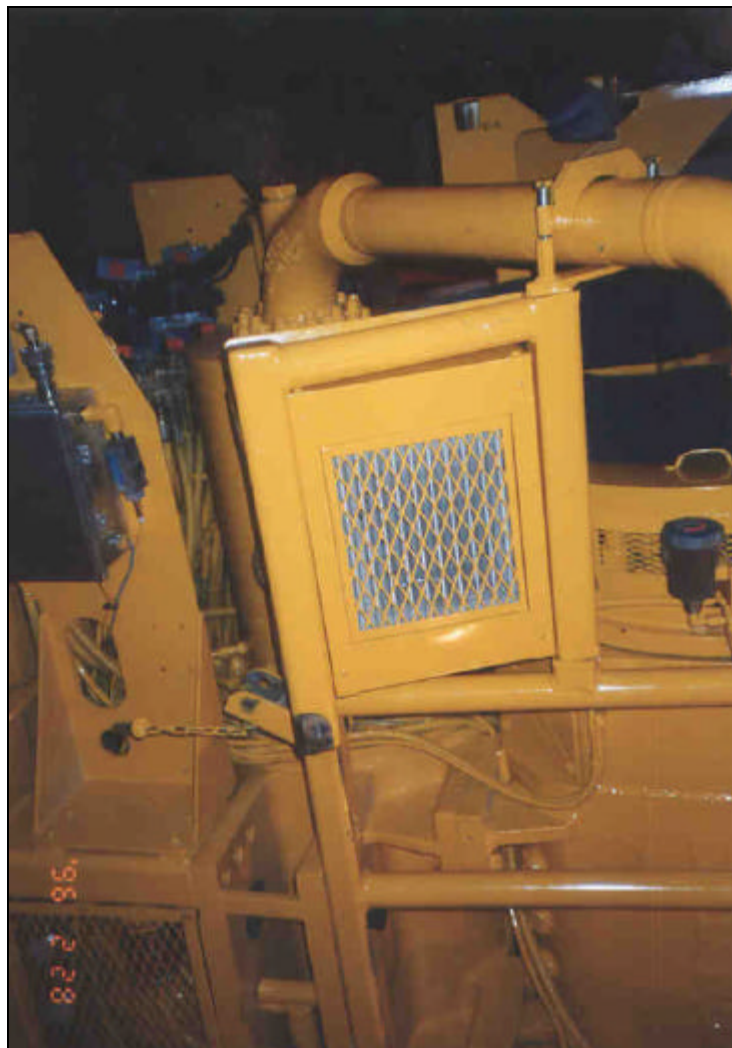
Figure 8-Insufficient Support
