DATE: April 5, 2004

SUBJECT: Blower Protection

SERIAL NUMBERS: All 4017AC Top Drives

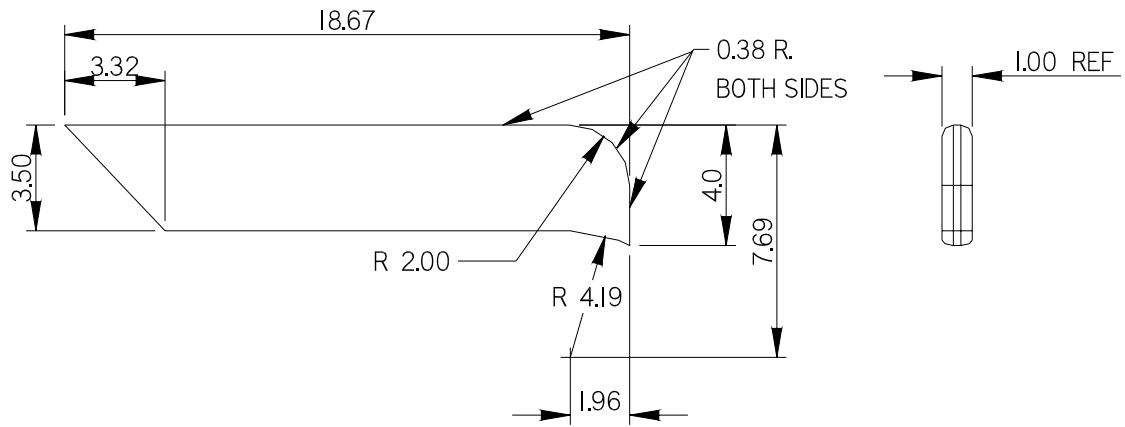
FIG.1

DISCUSSION: The blower on the top drive has potential to be damaged by tugger lines or the similar. This could cause the blower, or a portion of, to become dislodged from its mount and fall.

1. The blower needs to be further protected with the addition of a deflector plate which is welded to the top drive guard. The deflector plate should be constructed as shown in Fig.1. Ensure that the edges shown are well rounded to prevent tugger lines from getting caught on it.
2. Cut away the perforated plate in the area shown in Fig.2. Replace the cut away piece with $\frac{1}{4}$ " thick plate or flat bar which measures 2.50" x 6.00 ". This is to allow a stronger weld between the top drive guard and the deflector plate.
3. Weld the deflector plate onto the lower blower guard as shown in Fig.2. The plate should be centered on the pipe and a $\frac{1}{4}$ " fillet weld should be placed all around the plate on both sides.
