**PRODUCT: TOP DRIVE**

**DATE: March 7, 2011**

**SUBJECT:** Broken bolts on Top Drives with “Bat Wing” style guide frames

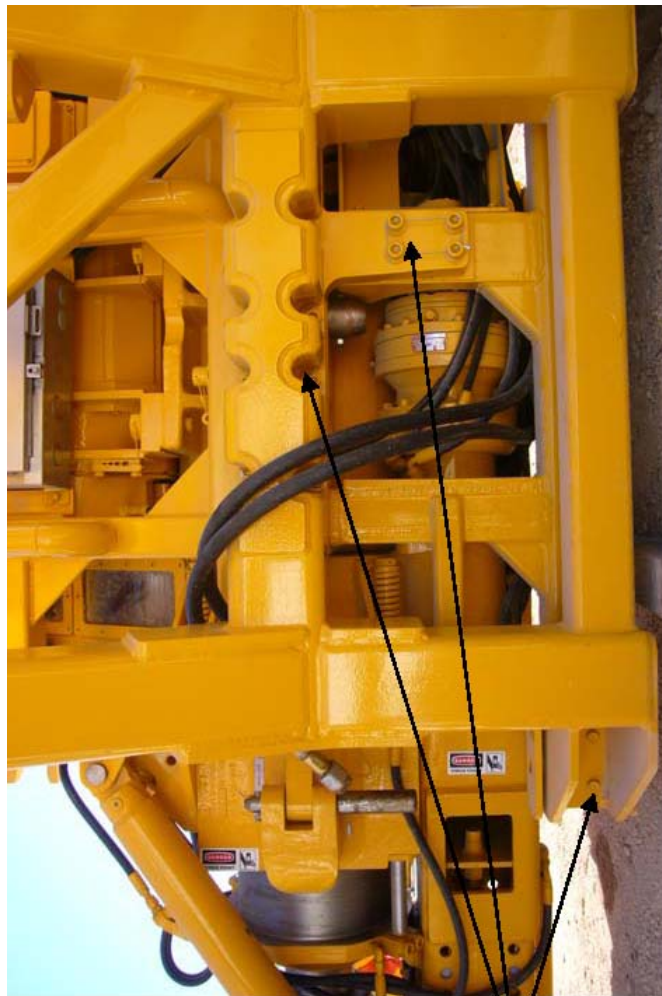
**DISCUSSION:** There has been an incident where the bolts attaching the Guide Runner Frame to the Main Housing have been breaking. Examination has revealed that when the Guide Runner Frame is made up correctly against the Main Housing, it may not be made up flush against the legs of the Frame Base; thus gaps are noticed as seen in the pictures bellow. When the mating surfaces are not made up correctly against each other, the bolts may not share the load equally and the potential for the bolts to fail prematurely exists.

Breaking Bolts

To eliminate the bolt breakage, inspect, shim if necessary and replace flat washers with Nordlock washers as outlined in the procedure below:

1 To ensure that the bolts (5/8" and 3/4") connecting the Guide Runner Frame to the Main Housing and the Frame Base are not bottoming on the inside of threaded holes, remove the bolts (one by one) and check the tapped depths for the 3/4" and 5/8" holes and ensure they have a minimum of 0.875" and 1.25" respectively. If the tapped depth is too shallow, a shim may be added between the main housing and the guide runner frame. (Note that Nordlock washers require 20% more torque.)

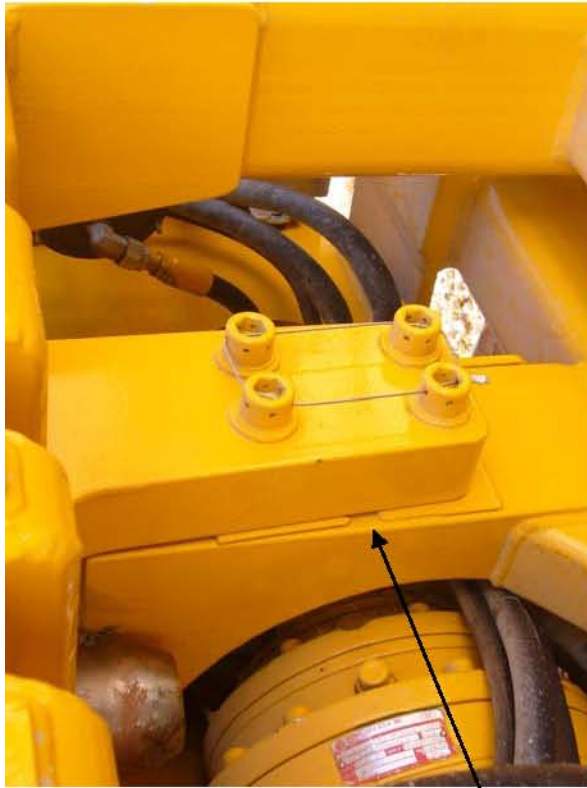
Gap between Frame  
Base Legs and Guide  
Runner Frame

Gap between the  
Frame Base and the  
Guide Runner Frame

6 With the housing to the Guide Runner Frame now tight, recheck the gap between the top drive Frame Base Legs and the Guide Runner Frame. Add enough shim to fill this gap. Replace the current washers with the Nordlock washers provided. Tighten these bolts to their recommended torques.

7 Recheck the gap between the top drive Frame Base and the Guide Runner Frame on both ends. Add enough shim to fill this gap. Replace the current washers with the Nordlock washers provided. Tighten these 1.0" bolts to 1018 Ft-Lb. (Torque values shown have already been increased by 20%.)

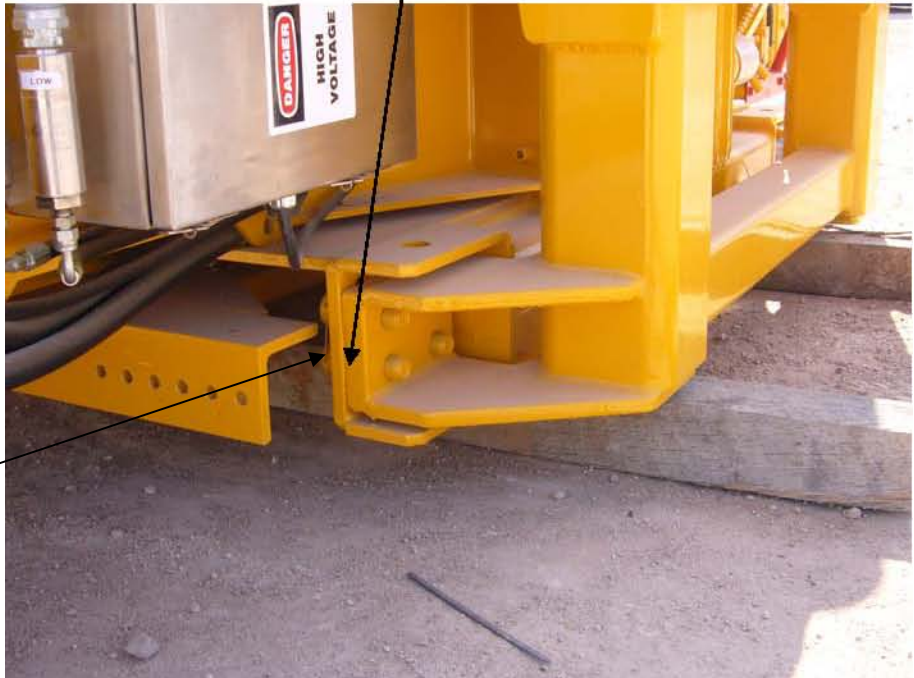
ADD 1/4" SPACER  
BETWEEN BOLT  
HEAD & TOP  
DRIVE FRAME

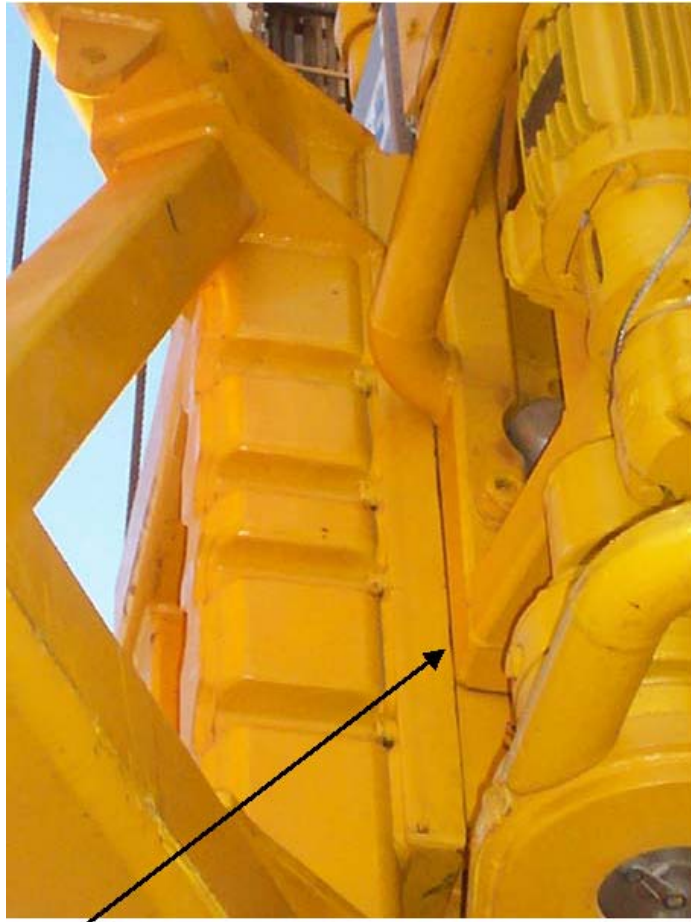
Possible gap between Main Housing and Guide Runner Frame

5 Start by adding shim between the housing and the Guide Runner Frame to take up any gap that was found between them in step 2. Replace the current washers with the Nordlock washers provided. Tighten these bolts to their recommended torques. 418 Ft-Lb for the 3/4" bolts and 238 Ft-Lb for the 5/8" bolts. (Torque values shown have already been increased by 20%.)

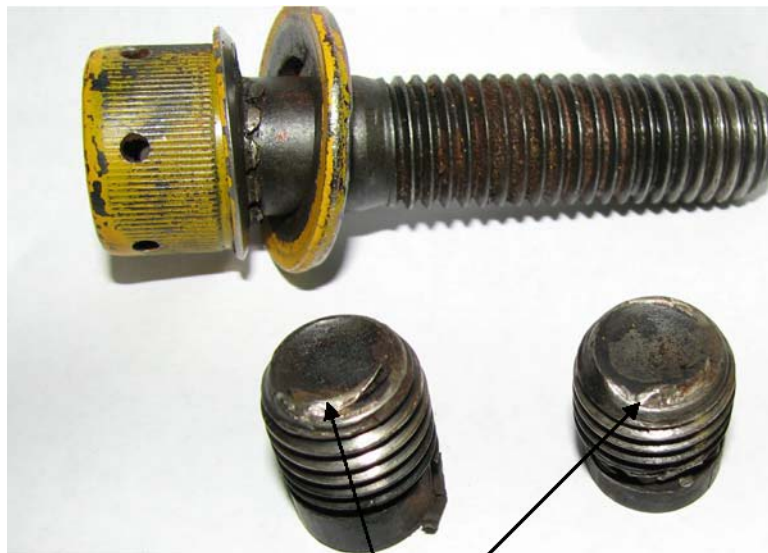
Returned bolts were examined and it was determined that some of the bolts have bottomed out in the hole rather than at the shoulder. This could have happened only if the threaded holes in the main housing and/or in the Frame Base Legs were tapped short or the bolts were too long.

Signs of bolts bottoming out in the tapped holes of the Main Housing and/or the Frame Base Legs
