PRODUCT: Portable Top Drive Systems

DATE: 9/26/11

SUBJECT: Torque Guide Section 1, Tensioning cylinders guard

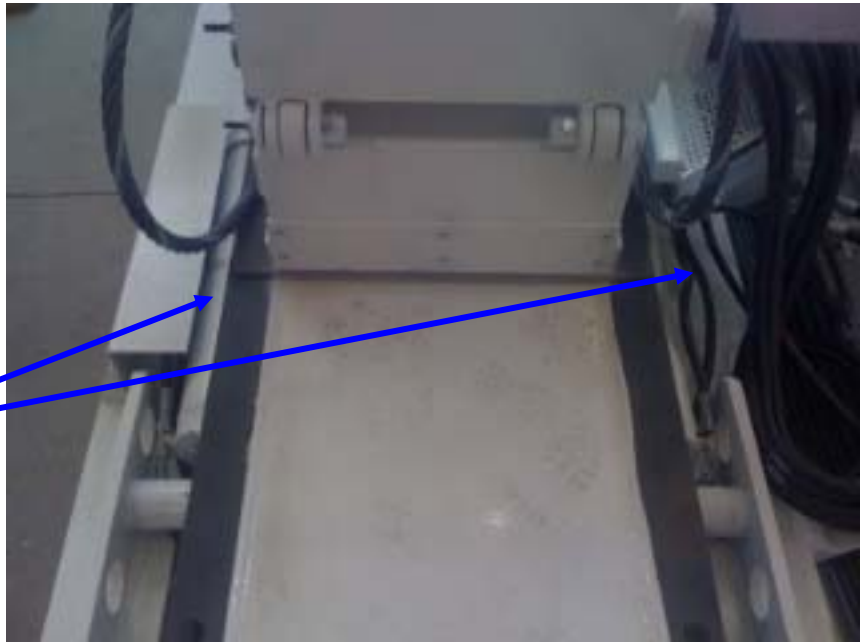
FIG. 1

DISCUSSION: A Guard around the Tensioning cylinders on the Torque Guide, Section 1, was only tack welded and this was missed on inspection. The tack welds subsequently failed, in the field, and the guard fell to the rig floor.

Location of  
Cylinder Guards  
Under Tensioning  
Cylinders

RECOMMENDATIONS: Immediately inspect the cylinder guards to verify they have sufficient welds.

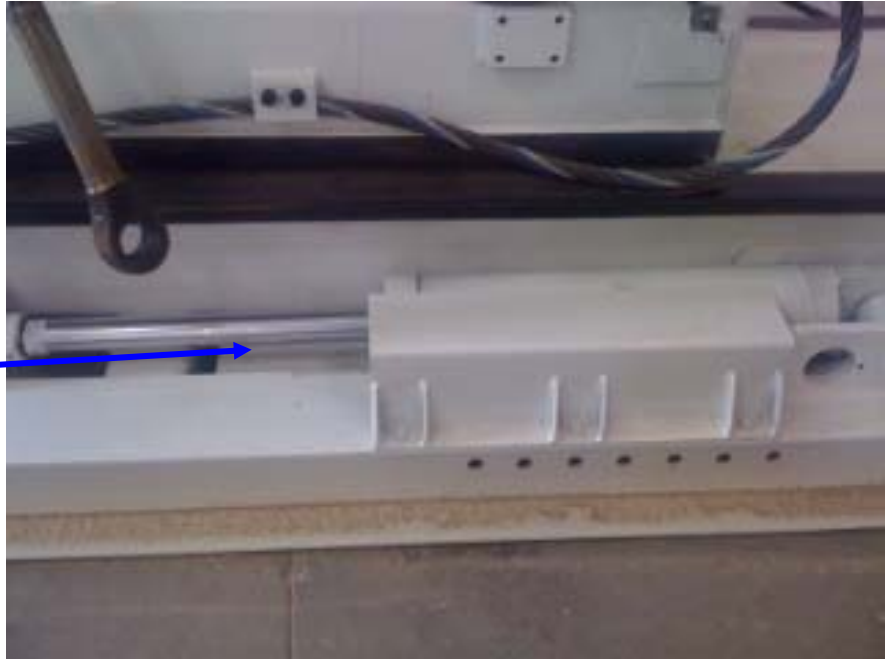
FIG.2

Top View  
Of Cylinder Guard

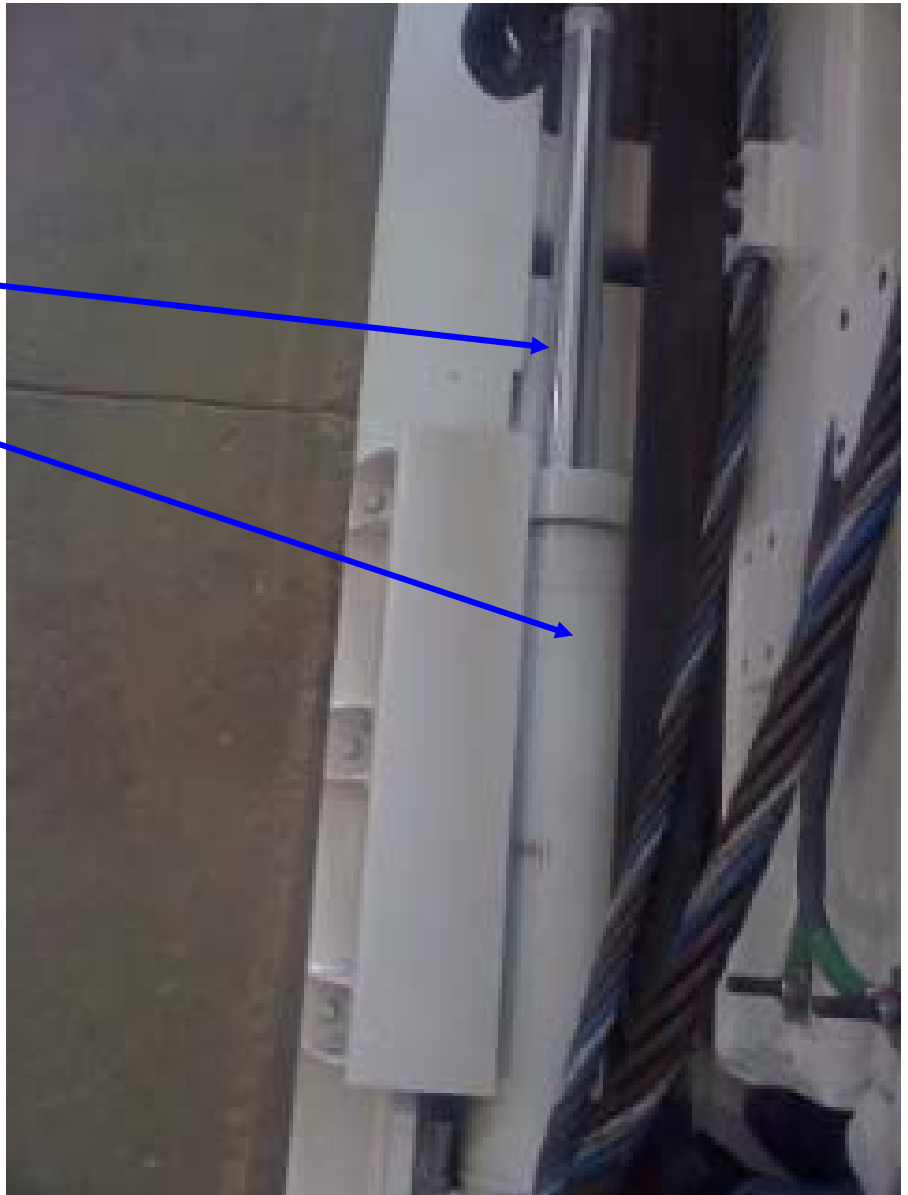
FIG. 3

Cylinder Guard

Tensioning Cylinder

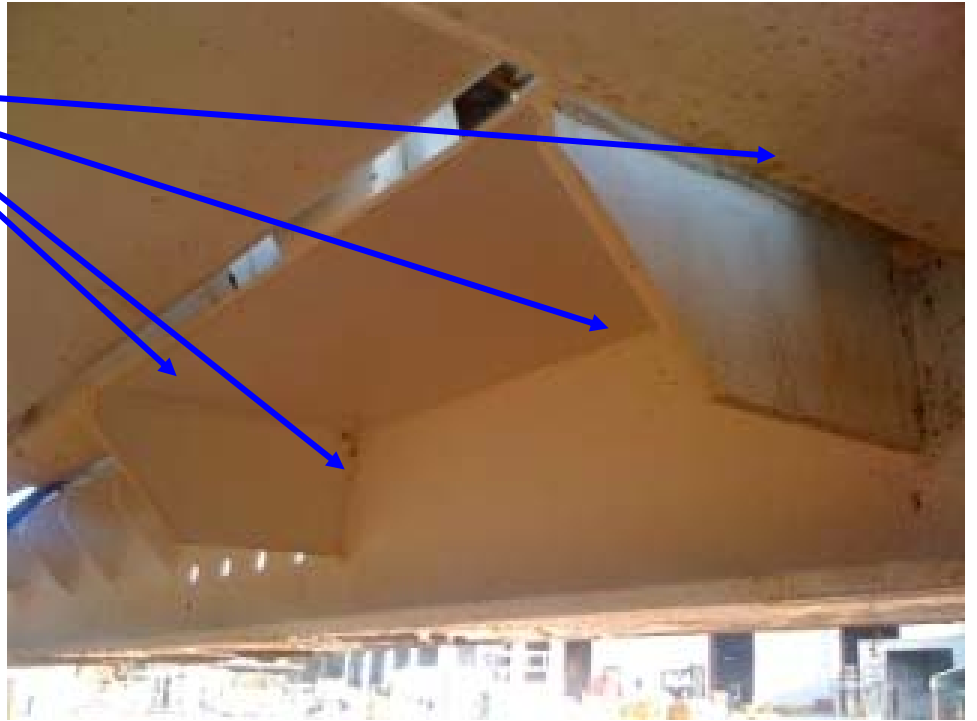
FIG. 4

Weld inspection  
Areas

1. If there are insufficient welds, or only tack welds. Properly secure the plate to insure it does not fall to the rig floor until Repairs can be performed.
2. If welding is required, insure all equipment is turned off, and the ground for welding is located on the Torque Guide and as close to the welded area as possible.
3. Repairs can be performed using good welding practices for mild carbon steel.

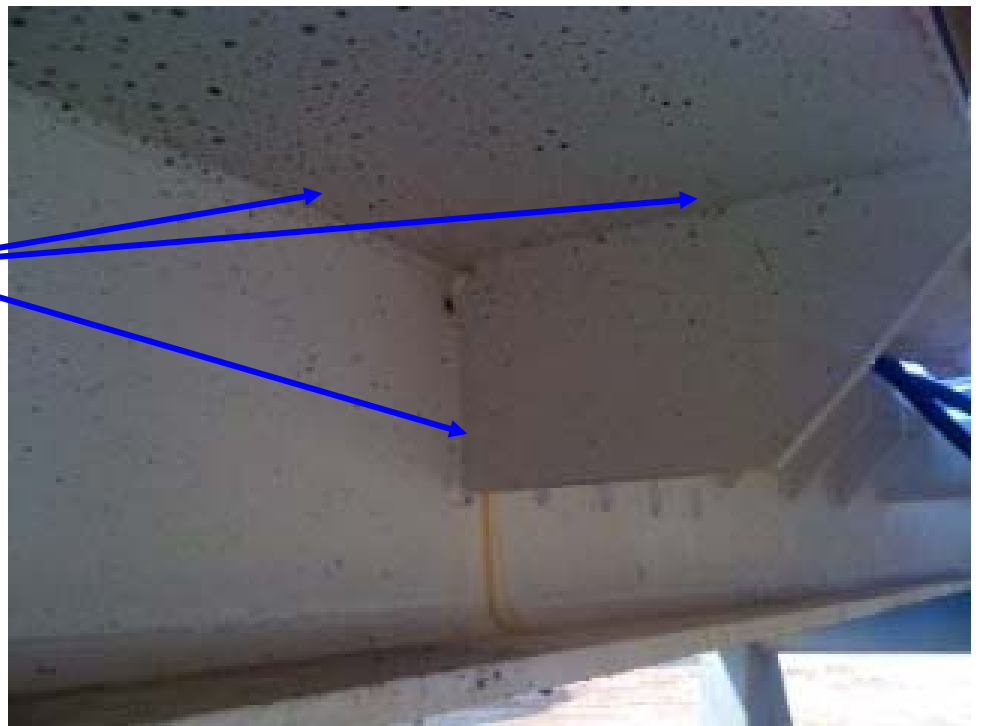
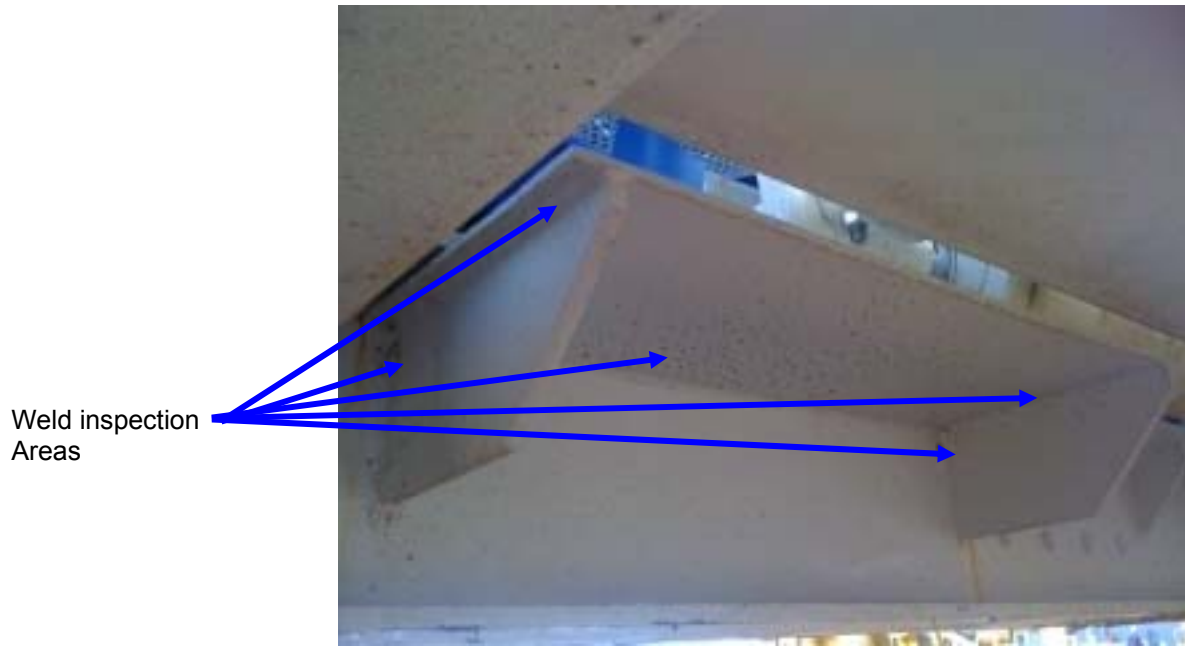
Weld inspection  
Area
