Safety Bulletin

No: SB031

Description: OEM 400 HP Motor Lead Wiring

The affected products include all EMI 400 top drives (both 150T and 250T) with unit numbers 500 and below that were manufactured before June 1, 2007.

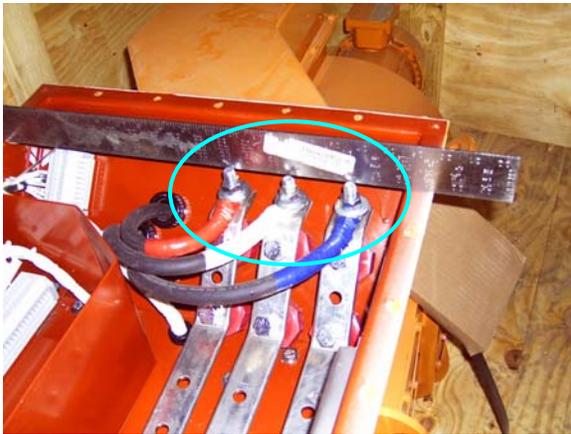
On 600VAC systems, the Canadian Electrical Code requires a 1" clearance between busbars, including electrical terminations, and any grounded surface. Figure 1 verifies that a minimum of 1" clearance is not maintained between the busbar motor termination bolts and the motor junction box cover.

Figure 1 – Insufficient clearance between 600VAC motor connections and junction box enclosure

Figure 2 illustrates how a minimum of 1" clearance between the motor terminations and junction box cover can be maintained by relocating the motor terminations to the center of the busbars.

6. Ensure 1" clearance between busbars, including electrical terminations, and motor junction box enclosure is maintained.
 - a. If required, correct by moving motor terminations from top of busbars to middle of busbars between insulators. Ensure that motor lead order is maintained.
7. Torque the motor lead bolts to 75 ft-lb upon reassembly.
8. Apply new protective electrical tape.
9. Replace junction box lid and safety wire bolts.

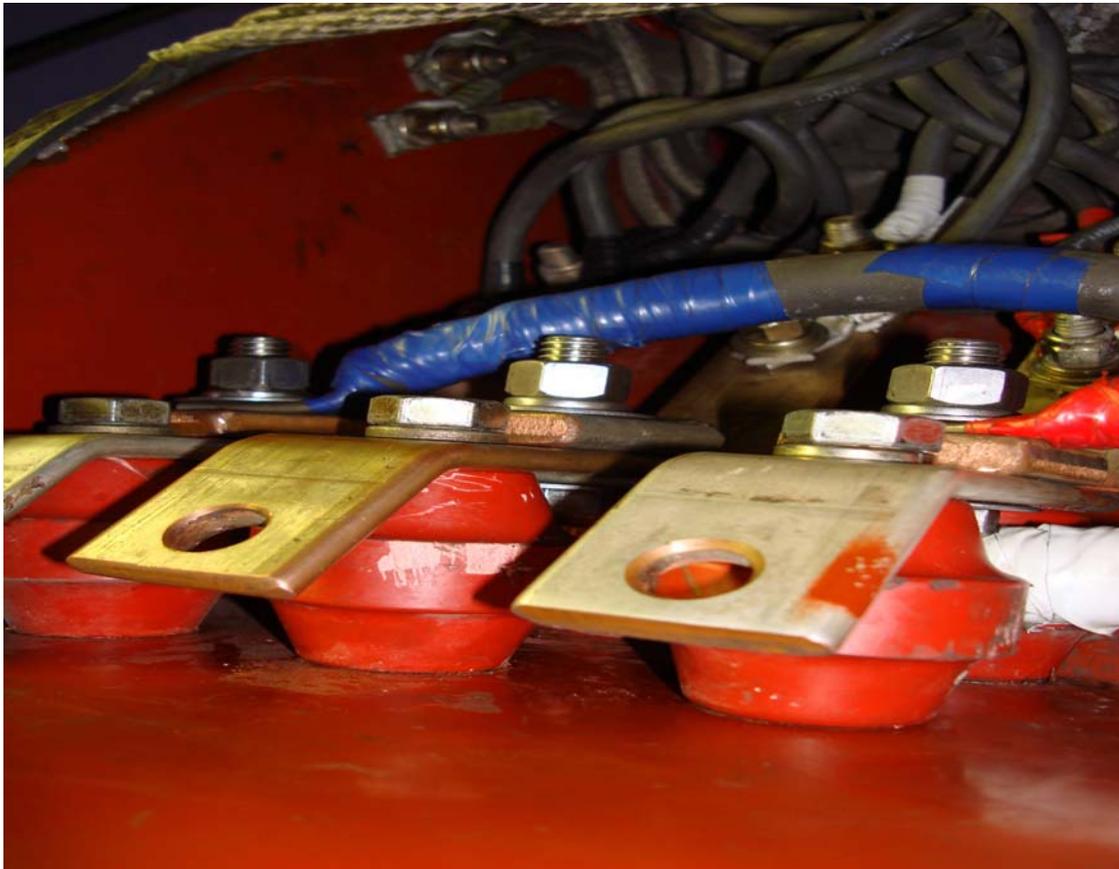
Figure 2 – Sufficient clearance maintained between 600VAC motor connections and junction box enclosure

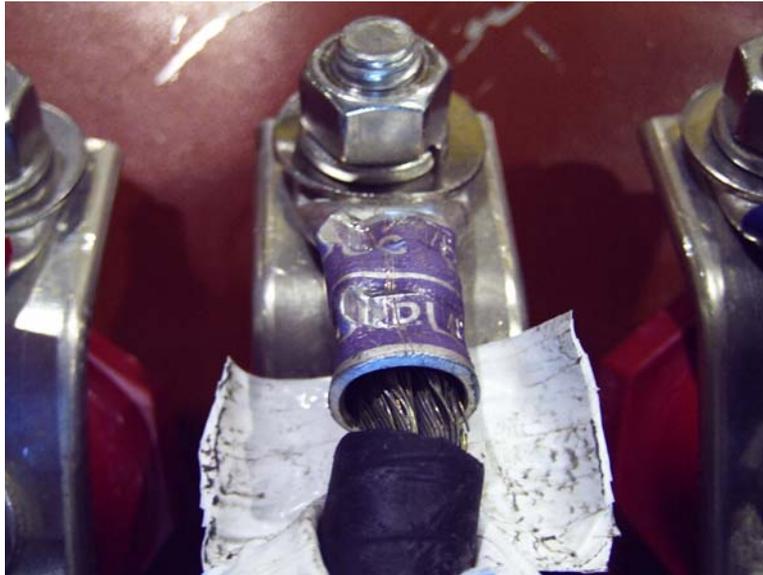
Figure 3 shows an improperly terminated motor cable lug. It shows that the termination lug is not secured by either of the approved methods; as well, an improperly sized lug was used. This may cause a condition where the motor lead connection is susceptible to failure and could lead to a shock or shorting hazard.

Figure 3 – Incorrect motor termination. 4/0 gauge (purple) crimp lug on 2/0 gauge wire, not crimped and soldered or crimped utilizing a hexagonal style crimping die

If required install the correctly sized crimping lug utilizing a cUL/UL approved hexagonal style crimping die (i.e.; Greenlee “U” style dies).

- For OEM motors with 2/0 cable, replace with a 3/0 gauge lug with ½” mounting hole. TESCO PN 14637 is the correct crimp lug to use for this connection. This lug must be crimped using a #50 crimp die. Take care to ensure the lead order is maintained.
- For OEM motors with 3/0 cable, replace with a 4/0 gauge lug with ½” mounting hole. This lug must be crimped using a #54H crimp die. Take care to ensure the lead order is maintained.
- For OEM motors with 4/0 cable, replace with a 250 gauge lug with ½” mounting hole. TESCO PN 4570 is the correct crimp lug to use for this connection. This lug must be crimped using a #62 crimp die. Take care to ensure the lead order is maintained.

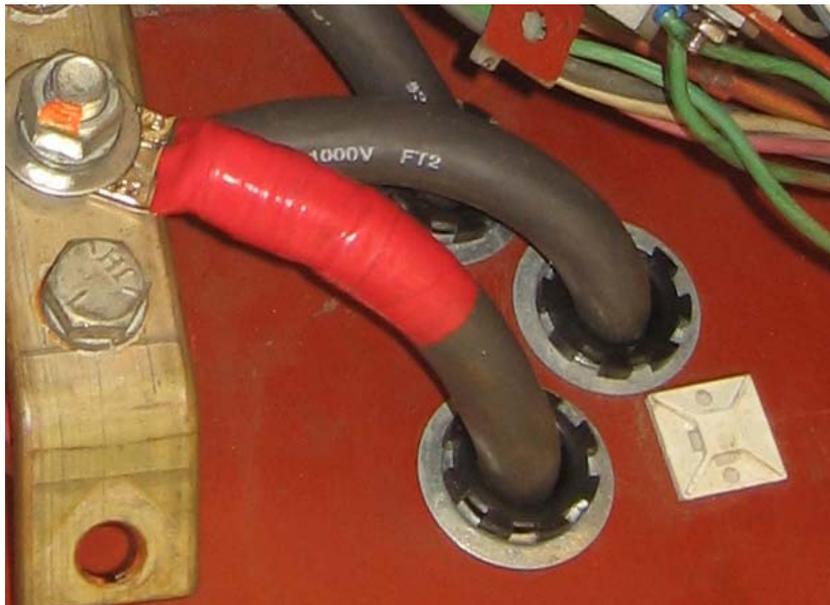
As shown in Figure 5 below, an air gap was found around the motor leads where the leads enter the junction box. This gap must be properly sealed because water, dust, or other debris could enter the junction box and create an electrical hazard.

Figure 5 – Air gap around motor leads entering junction box

Figure 6 illustrates the corrective action, which is the installation of cable sealing glands around the motor leads at the entry point, thus eliminating the air gap.

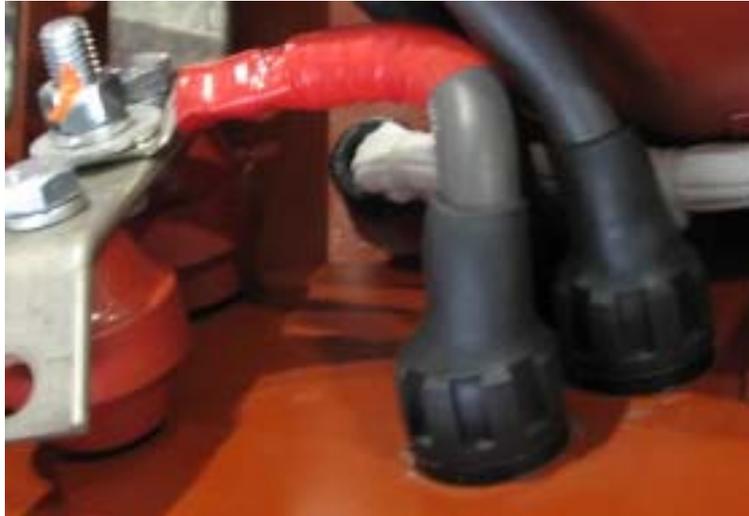
Figure 6 – Sealing gland eliminates air gap around motor leads entering junction box

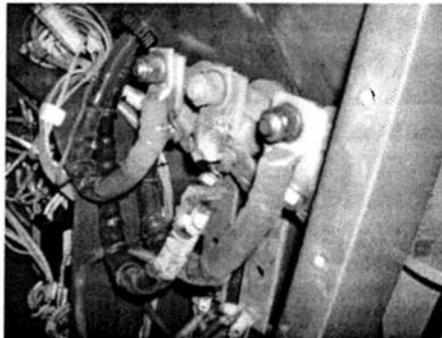
Figure 7 – OEM Service Bulletin # 201

- 2.0 Issue:**
1. Motors were built with 200° C 2/0 cable and 90° C 4/0 lugs. This has caused lead wires to burn open.
 2. There is an air gap around motor leads entering J-box. This causes water and mud to enter j-box.
 3. Conductor termination hardware interfering with J-box cover. This causes a safety hazard due to insufficient electrical clearance.

- 3.0 Fix:**
1. Install 200° C Nickel plated high temperature ½" hole long barrel lugs.
 2. Install insulated bushings around cables and move conductors to holes in between insulators.
 3. Move conductors to holes in between insulators.

- 4.0 Actions:**
- Remove existing lugs from all field motors with aforementioned 2/0 cable.
 - Replace grommet for cable entering junction box with a heat-shrinkable insulated bushing. It is acceptable for this bushing to be installed with the heat shrink on the plenum (non-junction box) side.

- Crimp and solder high temperature 3/0 nickel plated lugs to the lead wire. 3/0 lugs are acceptable due to the increased size of the flexible 2/0 cable.
