Safety Bulletin

No: SB040

Description: EMI 400 Blower Motor
Mounting Plate

Tesco 400HP Top Drive Motor

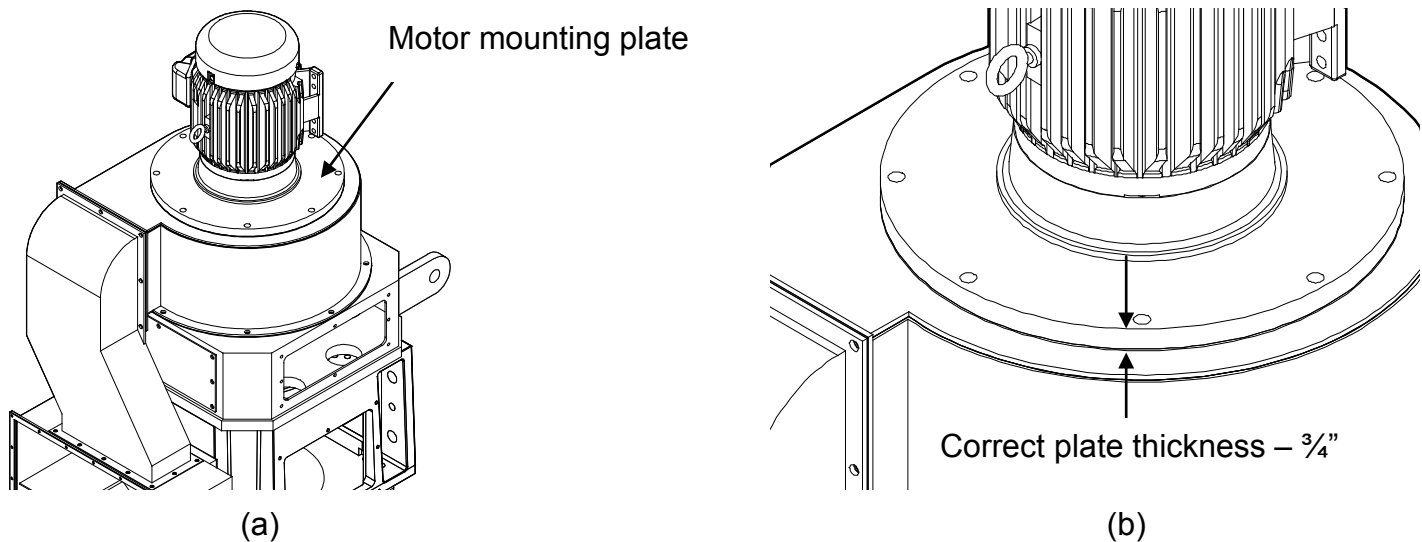
An incident occurred where the blower motor on an LTI TT400 induction motor became detached from its mounting plate (see Figure 1b). These motors are built by LeTourneau Technologies, Inc. (LTI) and can be identified as such on the motor data plate. A subsequent incident investigation determined that LTI had occasionally substituted a mounting plate of insufficient thickness which prevented the motor from being tightly bolted to the mounting plate. This left the motor slightly loose and able to vibrate during operation leading to failure of the motor mounting bolts and eventual detachment from the mounting plate. Additional details are provided in the attached LTI Product Bulletin LTI-PB-MTR-001.

Figure 1 – (a) Blower motor mounting plate, (b) plate thickness

1. Inspect and measure the blower motor mounting plate thickness as shown in Figure 1b.
2. If plate thickness is less than $\frac{3}{4}$ " nominal, remove from service and contact your local TESCO representative to order a replacement motor mounting plate.
3. If applicable replace motor mounting plate. Ensure thread locking compound and safety wires are replaced as necessary.

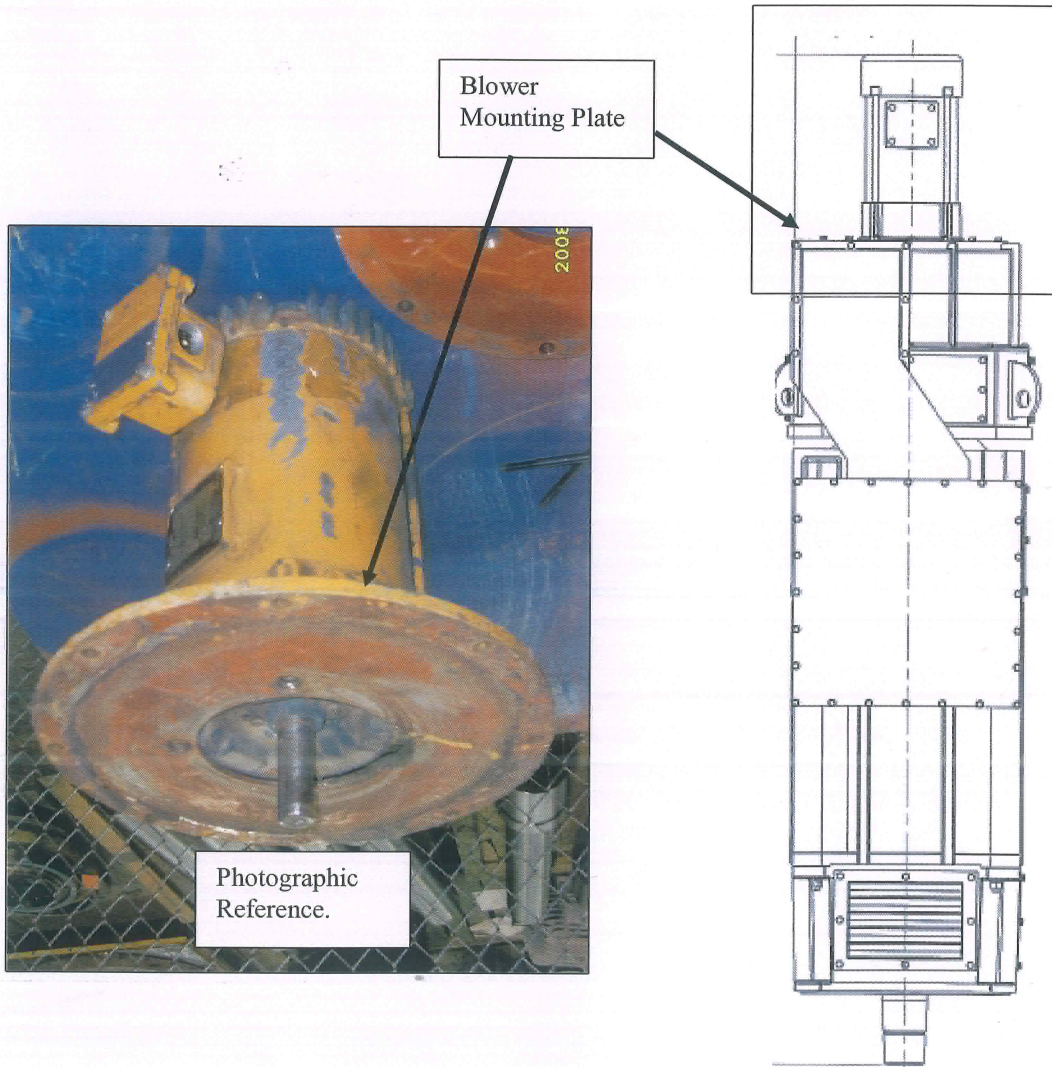
1.0 Description of Affected Products : Tesco 400HP Top Drive Motor

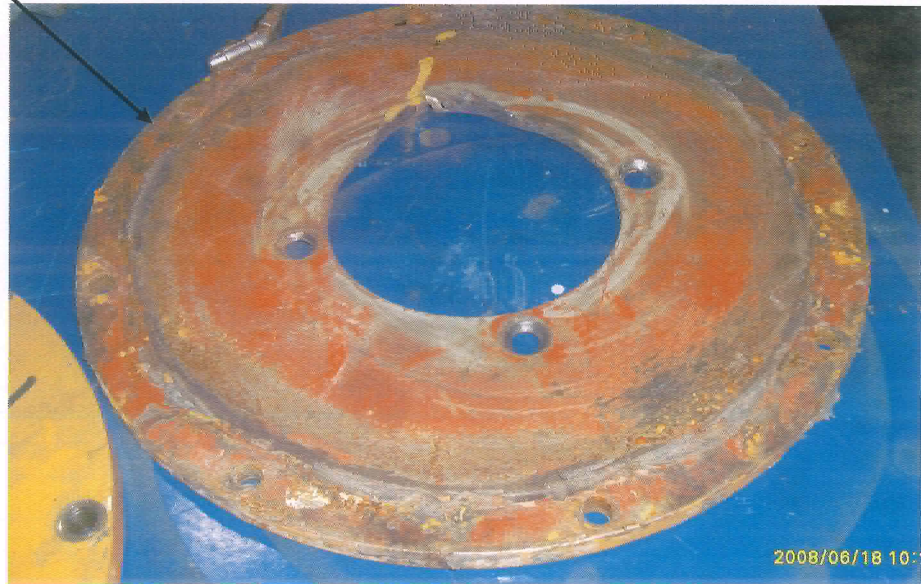
2.0 Issue: The mounting plate supplied with some Tesco 400HP motors was of insufficient thickness. In some models the countersunk fasteners that attach the blower motor do not seat against the plate when fully tightened. This causes the blower motor to vibrate freely and damage the mounting plate and possibly shear the bolts. **The result is that the blower motor may become loose and present a falling object hazard to personnel.**

DAMAGED
BLOWER MOUNT
PLATE

3.0 Fix: The fix is to first determine if the plate is of proper thickness. Measure the plate to assure it is of 3/4" nominal size. If it is less than 3/4" remove from service and replace with LTI replacement part prior to being placing top drive back in service.

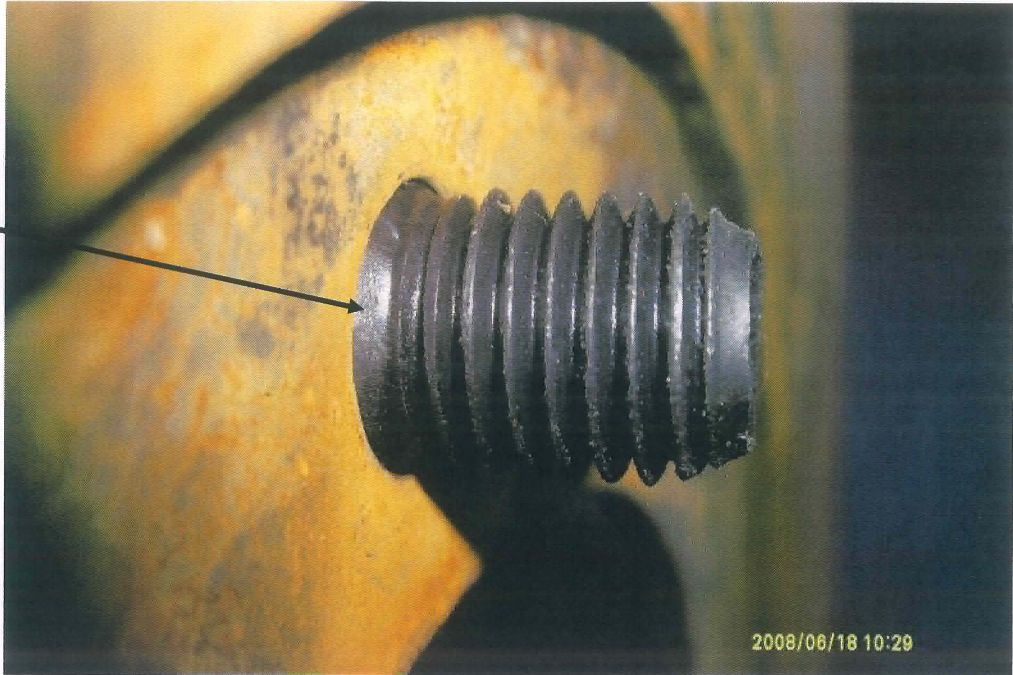
Protruding countersunk head prevents secure attachment of the blower motor.

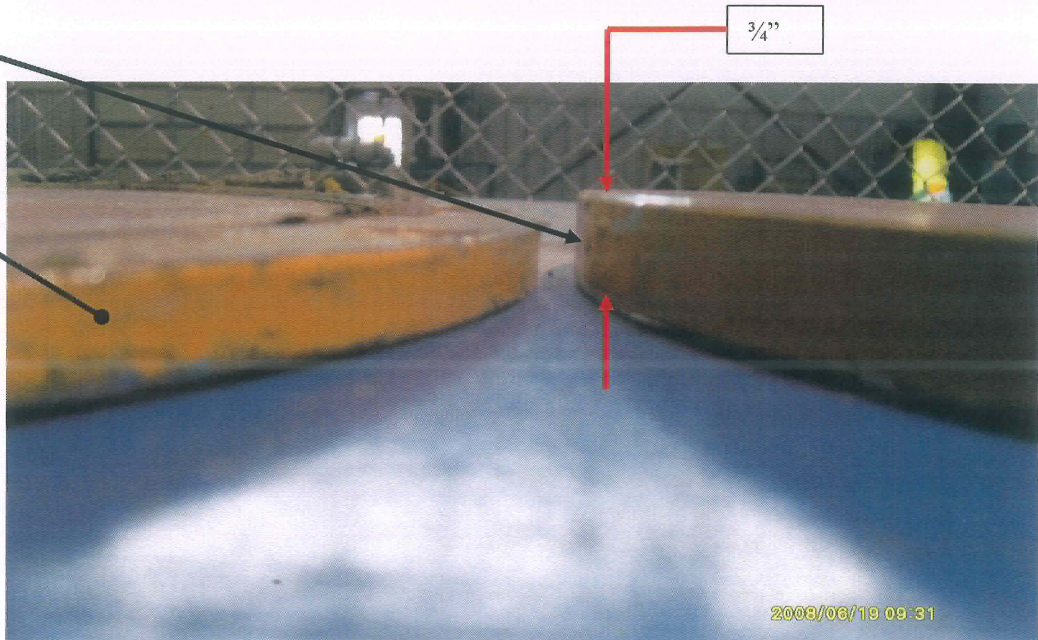
OK FOR SERVICE

REMOVE FROM SERVICE
-TOO THIN

Action(s): STOP USE IMMEDIATELY; CEASE USE UNTIL INSPECTION IS COMPLETED; Identify the blower plate type. If it is less than 3/4" remove from service and contact Le Tourneau Technologies Drilling Systems, Inc. field service department (Joe Hope, Engineer Manager 713-983-4811) for part number OEM4010A-K011 for a direct replacement. Replace with replacement part prior to being placed back in service.
