Safety Bulletin			  Tesco Corporation 5616 – 80th Avenue SE Calgary, Alberta, Canada T2C 4N5 Tel: 1-877-TESCO-77 (North America) Tel: 1 (713) 359-7195 (AMSS 24-hour support) Tel: 1 (713) 359-7295 (International) Email: bulletins@tescocorp.com www.tescocorp.com www.tescoparts.com	
No: SB091	Rev: 0	Date: March 11, 2016		
Secondary Retention on ESI-1000 / ESI-1350 Two-Piece Guards				
<input checked="" type="checkbox"/> Internal Use Only		<input type="checkbox"/> External Use	<input type="checkbox"/> Mandatory	<input checked="" type="checkbox"/> Recommended

Figure 1: ESI-1000 / ESI-1350 Two-Piece Guard

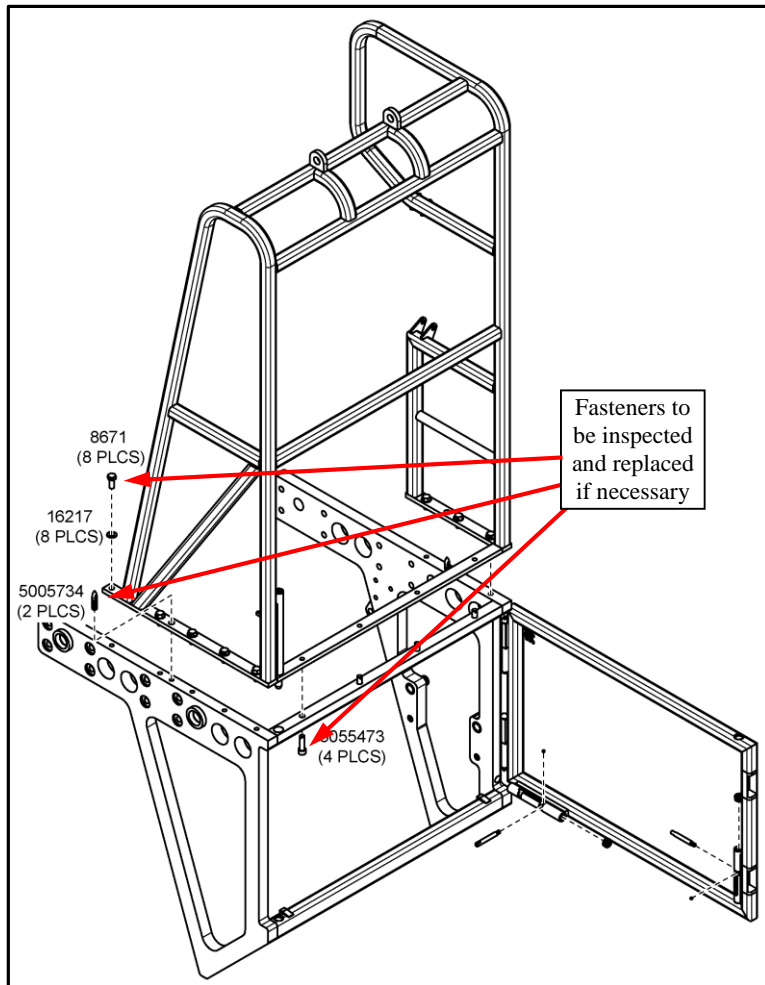
In 2014, the standard one-piece guard assembly used with Tesco ESI Top Drives was replaced with a two-piece guard (upper and lower). The two-piece guard provided more convenient access to assemblies and individual components during maintenance and transport of the top drive. During a routine review it was found that some of the fasteners securing the upper guard had not been supplied with drilled heads to permit secondary retention by lockwire.

To date there have been no reported instances of dropped fasteners or separation of the upper guard due to lack of lockwire secondary retention. However, fasteners without lockwire as a secondary retention could loosen during operation, and over time, lead to joint failure and dropped objects, resulting in avoidable incidents and unscheduled downtime.

At the earliest convenience, inspect the fasteners securing the ESI Top Drive upper guard. If they cannot be lockwired then they should be removed and replaced with the following fasteners:

Part Number	Quantity	Description
16217	8	Washer, Belleville, 2991 lbs, 3/4" ID x 1.5" OD, SS
5055473	4	Screw, Cap, Skt Hd, 3/4"-10UNC x 2 1/2", Dr Thd
5005734	2	Pin, Alignment, Guard, 500-ESI
