<b>Safety Bulletin</b>

Tesco Corporation 5616 – 80th Avenue SE Calgary, Alberta, Canada T2C 4N5 Tel: 1-877-TESCO-77 (North America) Tel: 1 (713) 359-7195 (AMSS 24-hour support) Tel: 1 (713) 359-7295 (International) Email: <a href="mailto:bulletins@tescocorp.com">bulletins@tescocorp.com</a> <a href="http://www.tescocorp.com">www.tescocorp.com</a> <a href="http://www.tescoparts.com">www.tescoparts.com</a>	
<b>No: SB101</b>	<b>Rev: 0</b>	<b>Date: October 12, 2016</b>		
<b>EXI Top Drive Torque Restraint/Dolly System Dropped Object Incident</b>

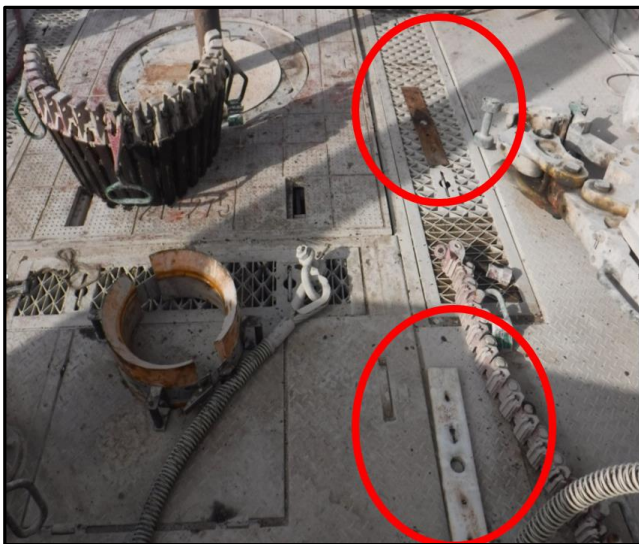
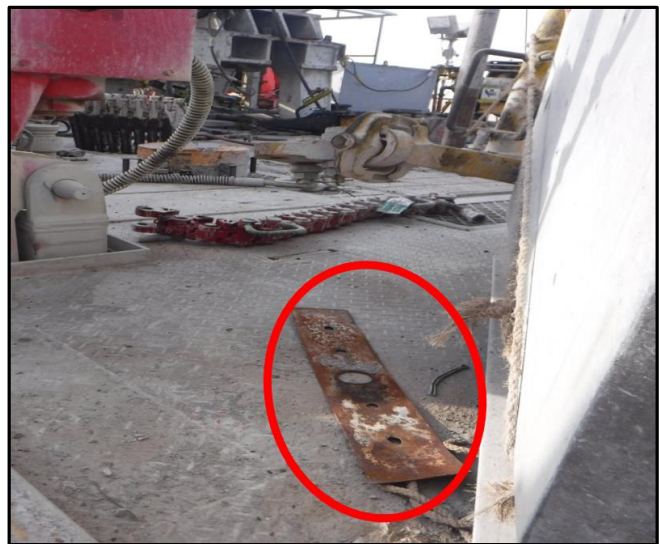
A dropped object incident was reported during a casing job where a dual-rail torque restraint liner and metal shim from a customer-owned Tesco EXI Top Drive fell to the rig floor. Weighing approximately 3 pounds (1.4 kg), the liner and shim (Figure 1) landed in front of the driller’s cabin from a height of 46 feet (14 meters). The casing job was stopped immediately. As the top drive was brought down for inspection a second shim fell from approximately the same height. The top drive and torque rails were inspected and a third shim was found to be loose as well; it was subsequently removed from the torque rail. There were no injuries to rig personnel.

**Figure 1: Bolts heads from torque restraint sheared, causing liner and metal shims to fall to the rig floor**

The Tesco Top Drive maintenance guides require a routine daily and weekly visual inspection of the torque restraint system including all liners for all models of top drives. The same inspection documented in the current maintenance manual for the torque track/torque bushing system is applicable to the dolly when used as a torque restraint system; the maintenance guide is being updated accordingly as per Figure 3. All customers using a dual-rail torque restraint system (dolly) are required to follow the maintenance guide and replace torque restraint liners when needed to avoid any risk of dropped liners/shims.

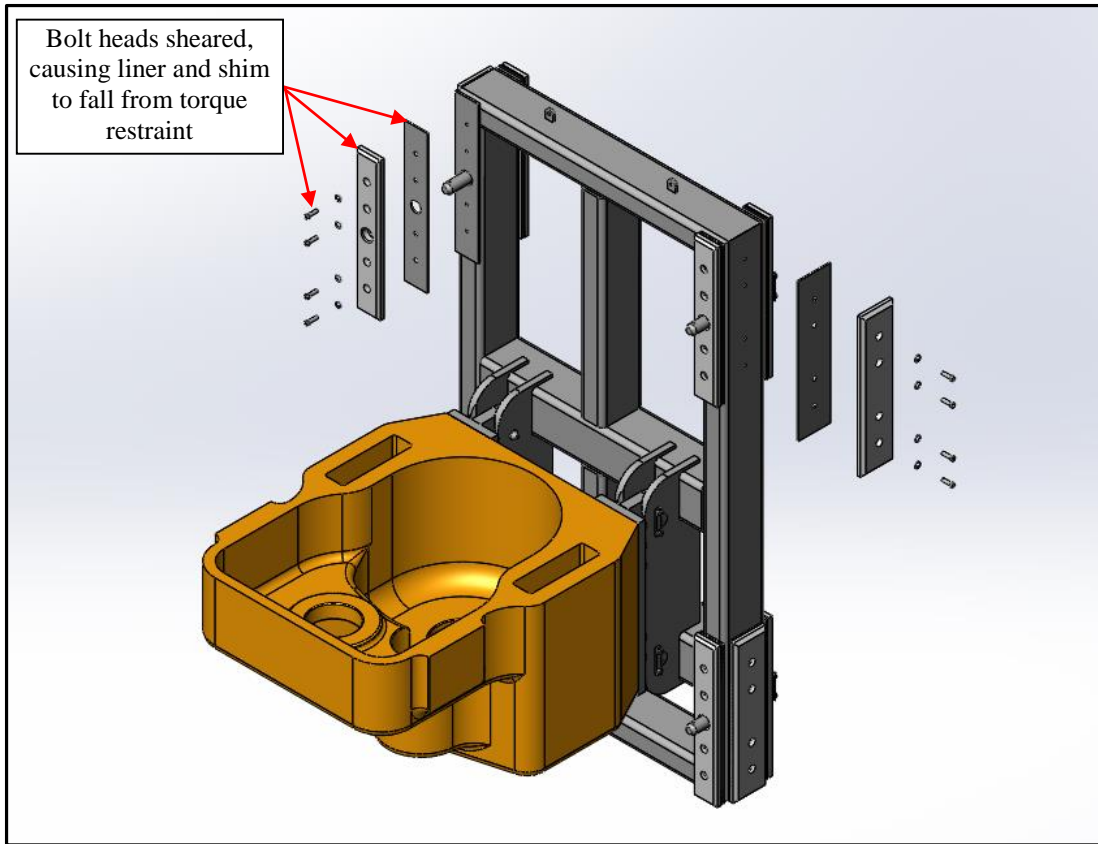
The top drive had been in operation for approximately six months when the incident happened. Initial reports indicate that the liner was worn past acceptable operating limits, exposing the liner bolts. This resulted in the bolts shearing off (Figure 2) which contributed to failure of the torque restraint liner described above. It is unclear at this time whether the torque restraint liner had undergone a prior visual inspection and replacement as recommended in the top drive maintenance guide.

**Figure 2: EXI Top Drive dual-rail torque restraint**
