Product Bulletin # TDS-260 Rev 1

# ABB Drives Backspin Issue – 17.01 DC Hold Parameter

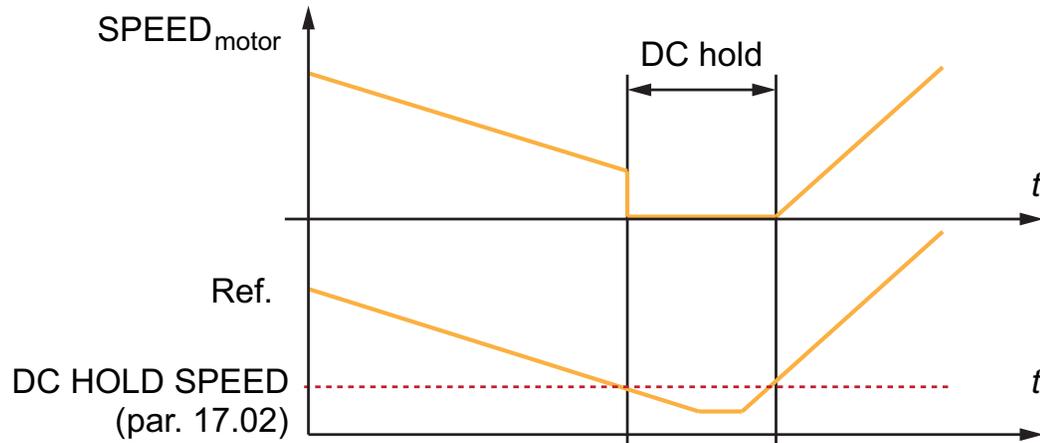
Figure 1: Parameter 17.01 DC HOLD

With drive parameter 17.01 DC Hold set to “1” (Active), zeroing the Top Drive RPM sets the drive to magnetizing current. This current level may be insufficient to hold torque in the drill string under load, potentially resulting in a backspin.

Always use the Top Drive Torque Unwind feature to ramp down torque before setting slips. (Reference: [Top Drive Torque Unwind Procedure: Bulletin TDS-133](#)).

- A Service Bulletin to follow with changes to Top Drive ABB drive parameters.
