Product Bulletin # TDS-266 Rev 1

Blower Deflector Inspection

Canrig Top Drive models C500-681, C500-865, C750-681, and C750-865.

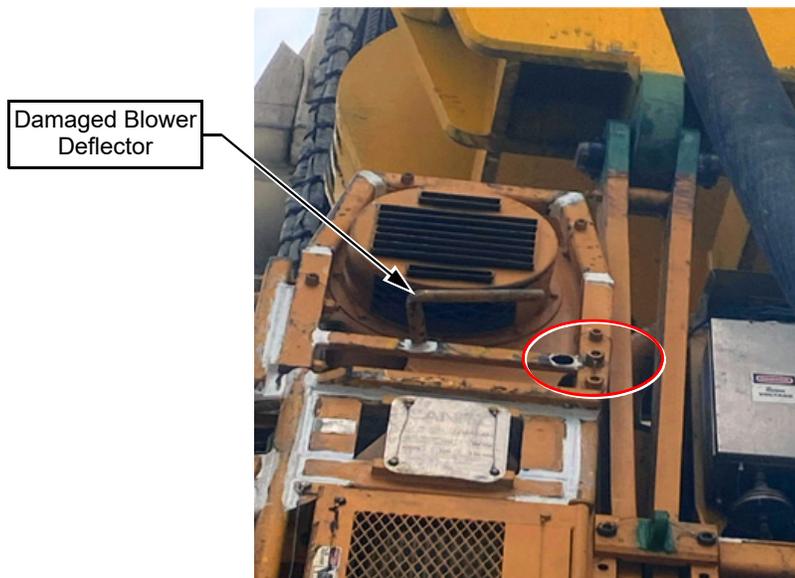
Canrig has become aware of an incident in which the blower deflector became entangled with a cable, and part of it became detached. The incident is still under investigation to determine the exact cause.

Figure 1: Damaged Top Drive Blower Deflector

- Visually inspect the blower deflector and the guard structure for any damage or deformation.
- Visually check for cracks in the welds.
- Repair or replace any damaged components.

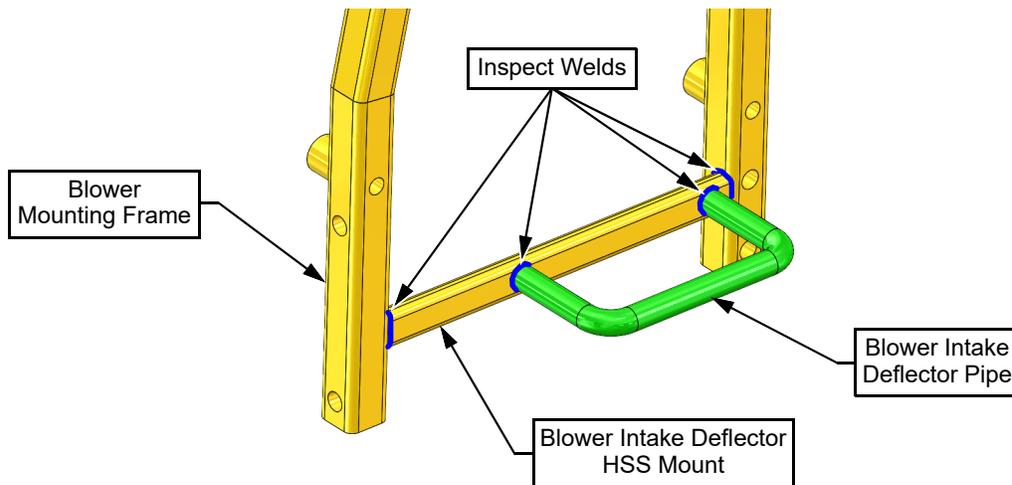
Figure 2: Blower Mounting Frame and Deflector
