**SUBJECT:** Improper Lugs on 6027TD AC Motor Leads

**SERIAL NUMBERS:** 239, 257, 265, 268, 270, 278, 279, 281, and 292

**Lug Identification Process**

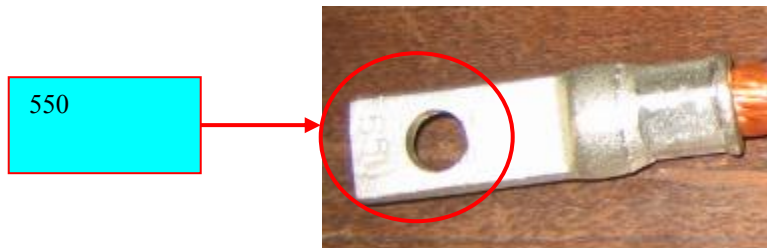
Step 2. For the non-factory lug, a quick way of identifying the correct lug is to check the inscription on the back; it should have 550 stamped on the back. FIGURE B  
Note: This may or may not require the de-lugging and re-lugging process.

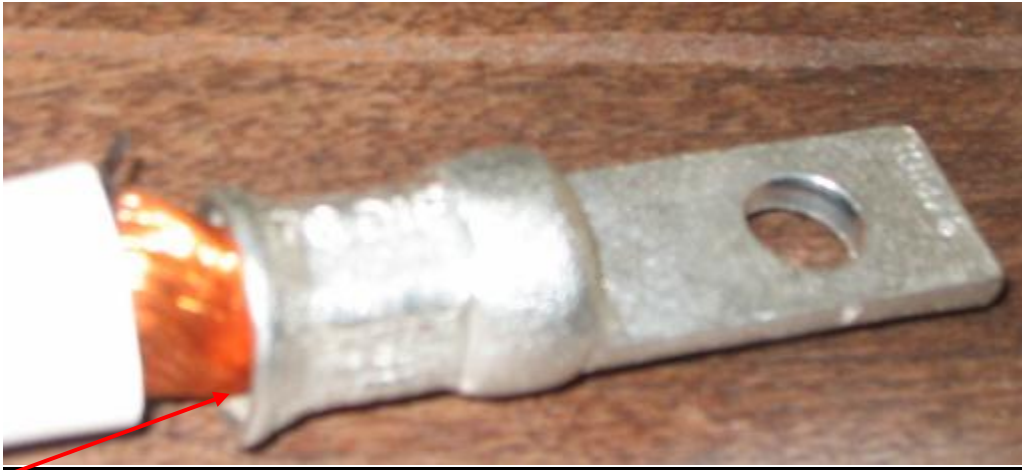
FIGURE C.

Step 3. An easy way of identifying the incorrect lug is as follow:

1. Check the stamp on back of the lug; it should have 775 stamped on the back.
2. If the wrong lug has been installed, a gap is visible. See FIGURE C

Air Gap

**RECOMMENDATION:** Inspect the lugs on the WEG AC motor leads at the earliest convenience following the attached inspection procedure. If the motor has the incorrect lug(s), contact CANRIG for a correct replacement lug(s), p/n E11083.
